GREENVILLE-SPARTANBURG INTERNATIONAL AIRPORT

DECEMBER 2019
AIRPORT MASTER PLAN UPDATE
APPENDIX A: PAVEMENT MANAGEMENT PLAN

AIRPORT PAVEMENT MANAGEMENT SYSTEM UPDATE

AUGUST 2018

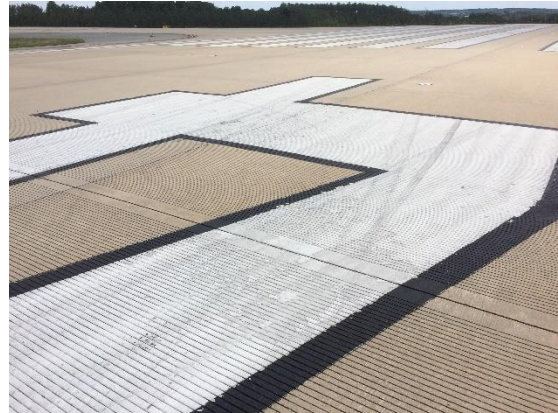
Runway 4 PCC pavement in excellent shape with no major pavement distresses (right)

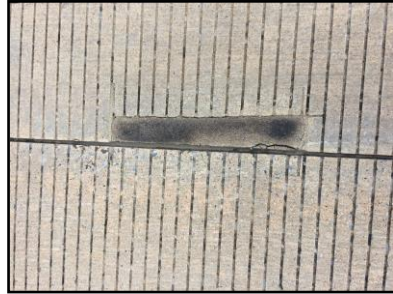
Along the northern end, Sections 100, 110, and 120 showed more distresses than the southern end. Although still in great condition, these sections showed lower PCI than the other PCC sections, having a 98, 99, and 95 PCI, respectively. The primary distresses on these PCC runway sections include shrinkage, spalling, and small patches.

Small Patch

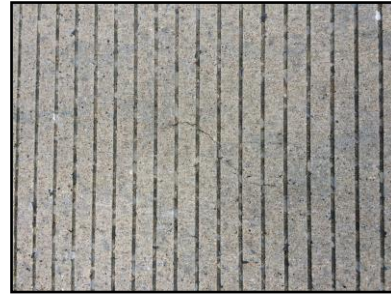
Shrinkage Crack

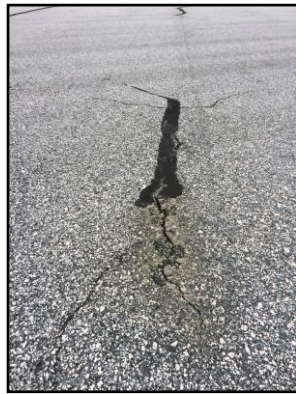
L&T Crack, Weathering
and Swelling

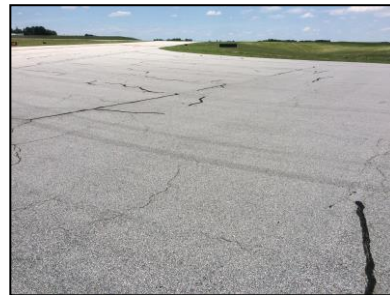
L&T Crack

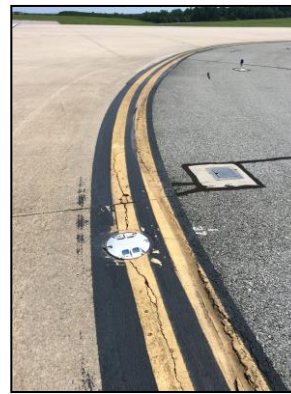
Linear Crack

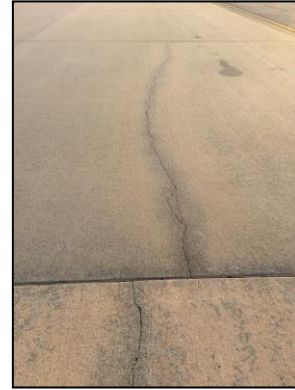
Linear Crack

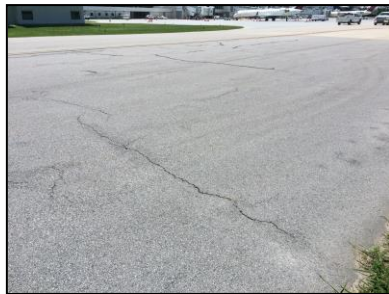
L&T Crack

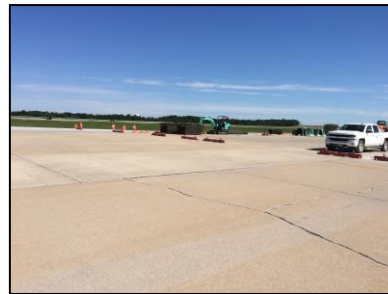
Linear Crack

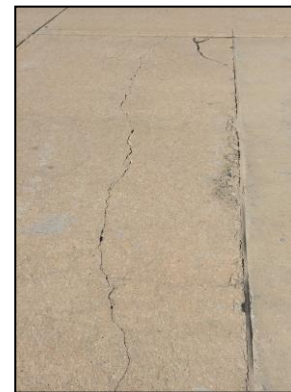
Linear Crack, Joint
Spall and Corner Spall

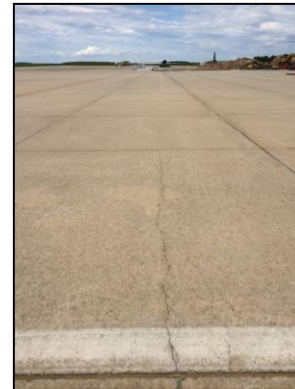
Linear Crack

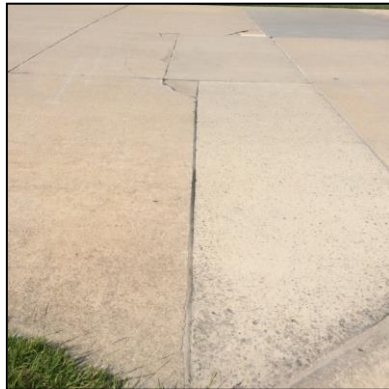
Corner Spall

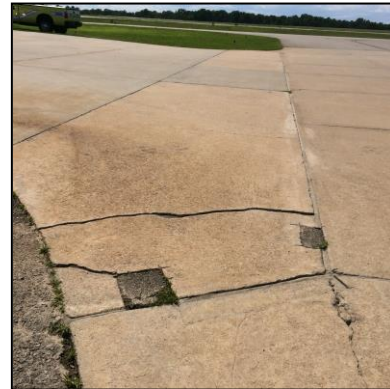
Corner Break, Corner Spall
and Small Patch

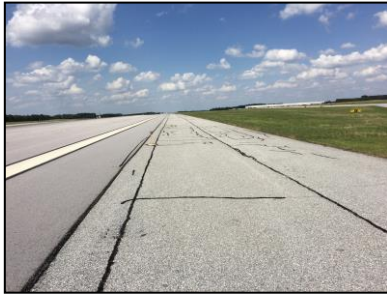
L&T Crack

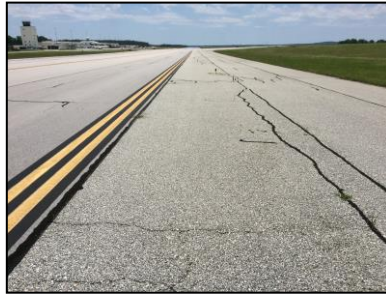
Block Crack, L&T Crack
and Swelling

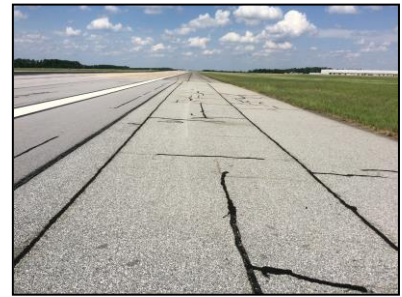
Block Crack and L&T Crack

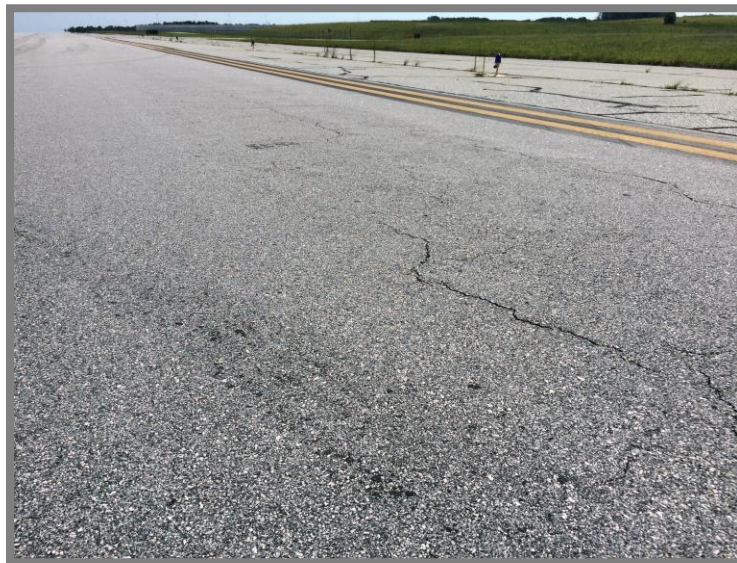
Bleeding is upward movement of asphalt in an asphalt pavement, resulting in the formation of a shiny, sticky film of asphalt on the surface. Bleeding primarily occurs when there is an excessive amount of asphalt cements or tar in the mix or the mix has a low air-void content. During hot weather, the asphalt fills the air voids and expands to the surface of the pavement. Since the bleeding process is not reversible during cold weather, asphalt or tar will accumulate on the surface.

Bleeding – Taxiway L

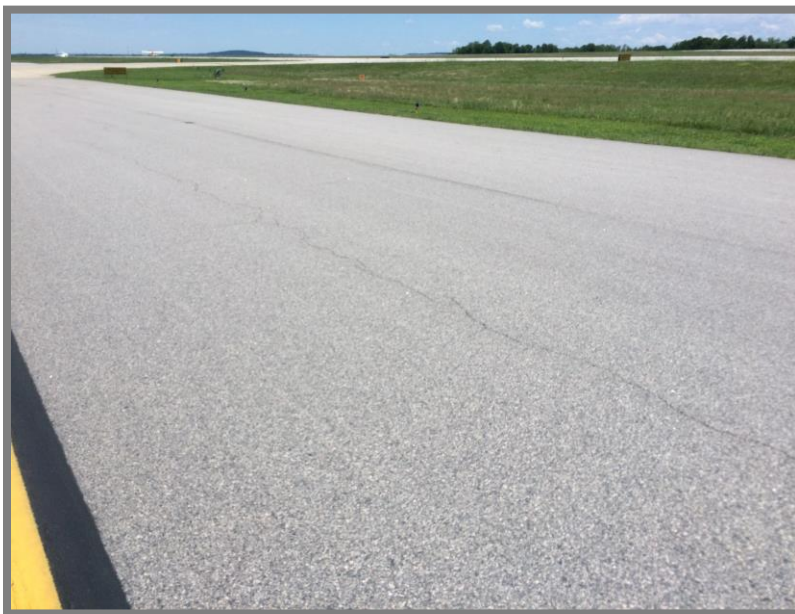
Longitudinal/Transverse Cracking – Taxiway 1

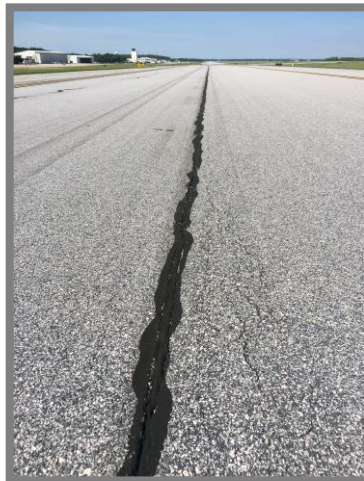
Longitudinal/Transverse Cracking – Taxiway L

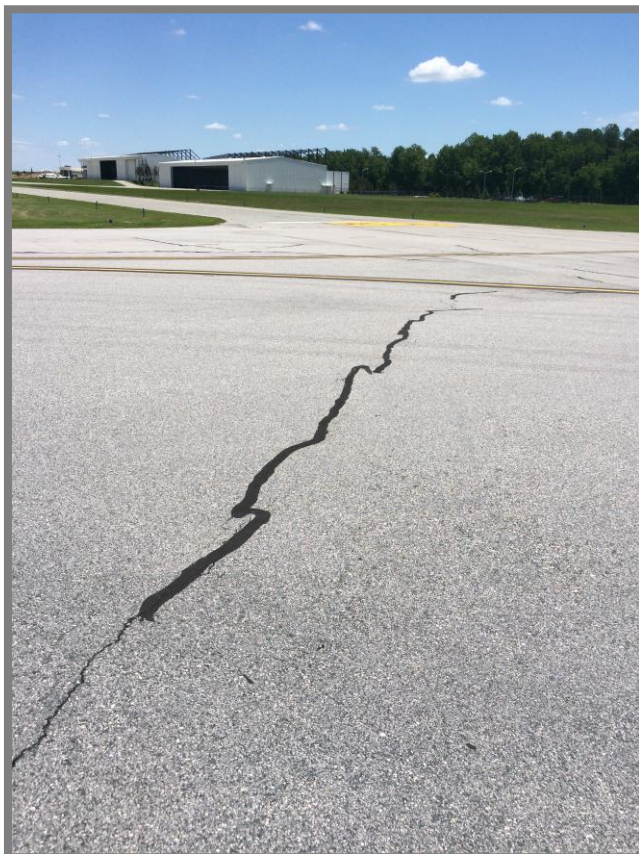
High-severity cracks are defined as having significant foreign object debris (FOD) due to severe spalling of the crack and often contain associated loose and broken pieces of pavement and the potential to cause damage to aircraft.

Longitudinal/Transverse Cracking – Taxiway E/F

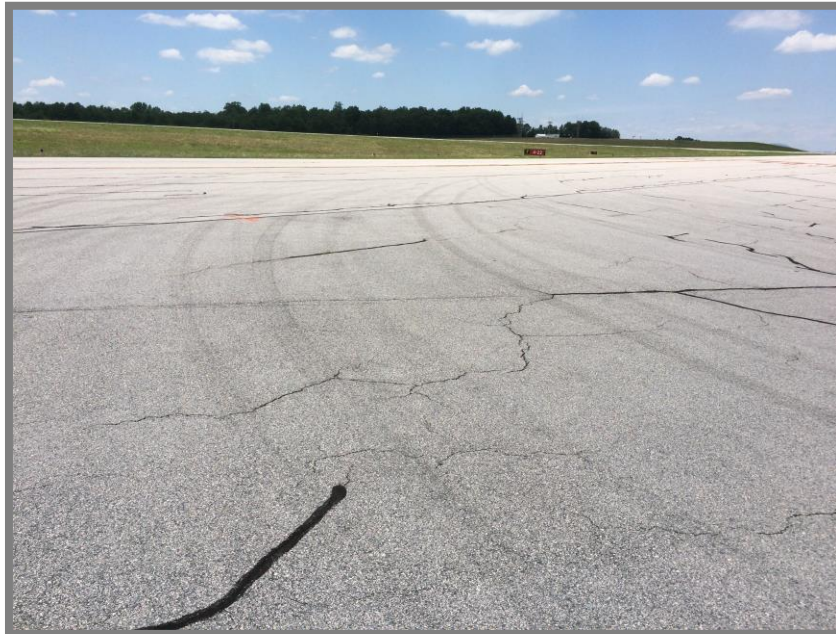
Block Cracking – Taxiway F & Taxiway L Intersection

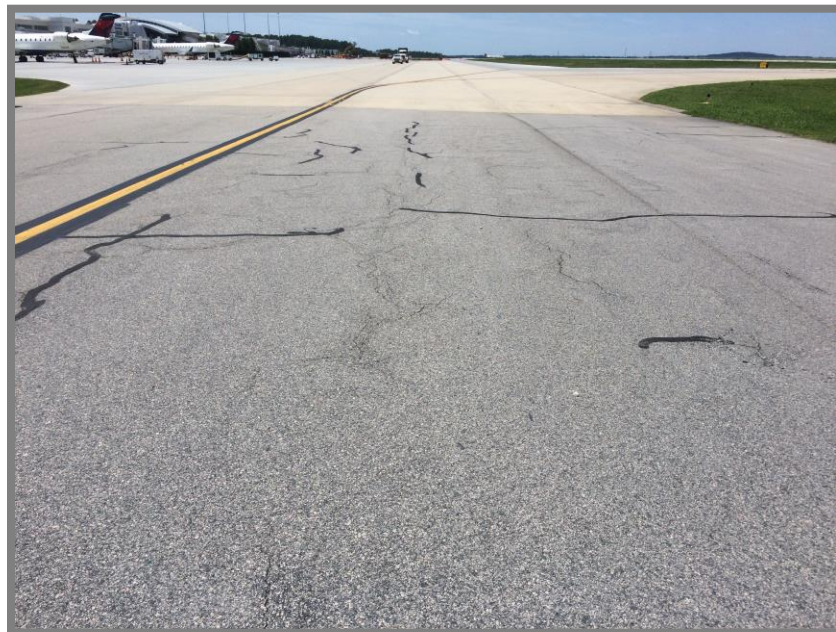
Block Cracking – Taxilane 1

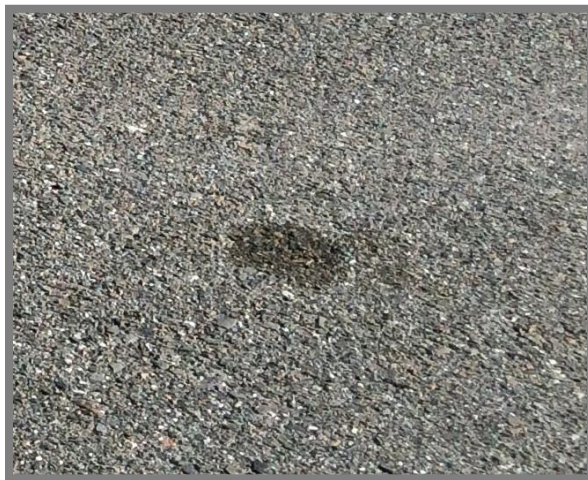
Oil Spillage

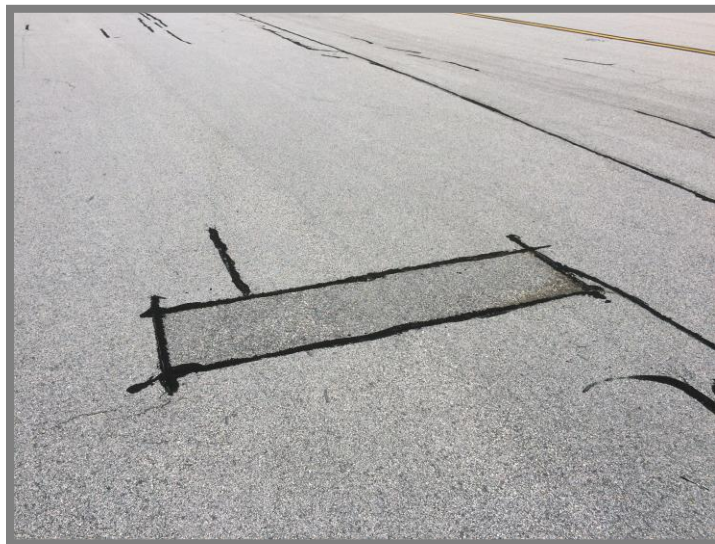
Patching – Taxiway G

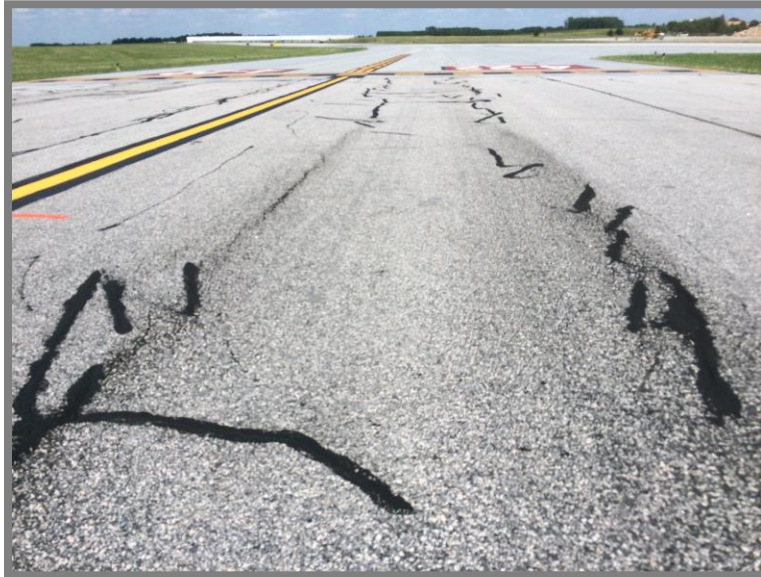
Rutting – Taxiway G

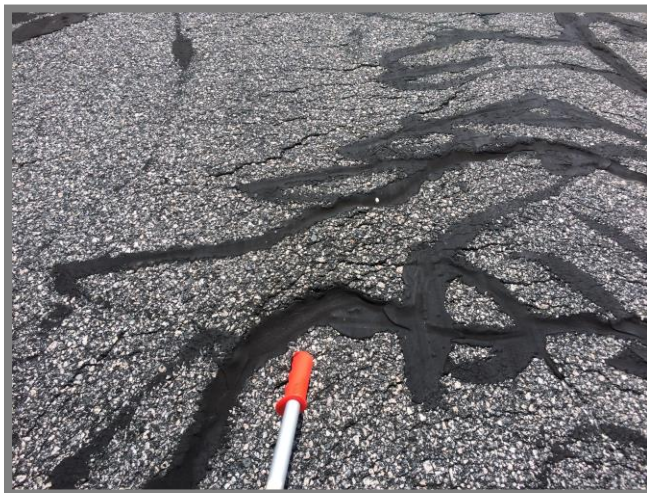
Slippage cracks are characterized by crescent-shaped cracks having two ends pointed away from the direction of traffic. These types of cracks are typically located near turning or breaking areas and are produced when the turning or breaking of aircraft cause the pavement surface to deform. Slippage cracks were primarily observed on Taxiway G at GSP.

Slippage Cracking – Taxiway G

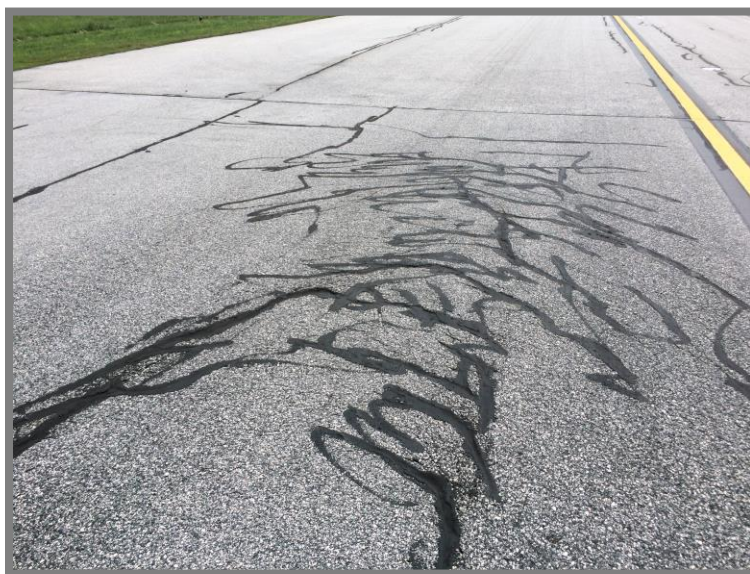
Slippage Cracking – Taxiway G

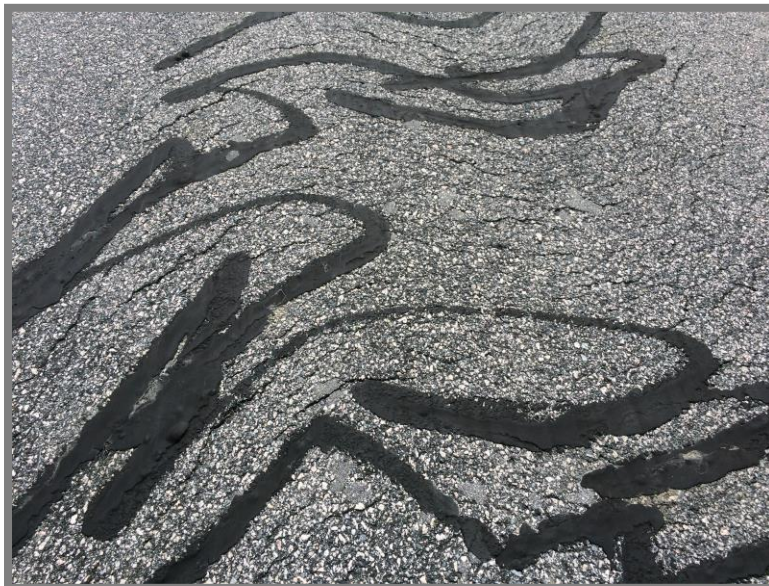
Slippage Cracking – Taxiway G

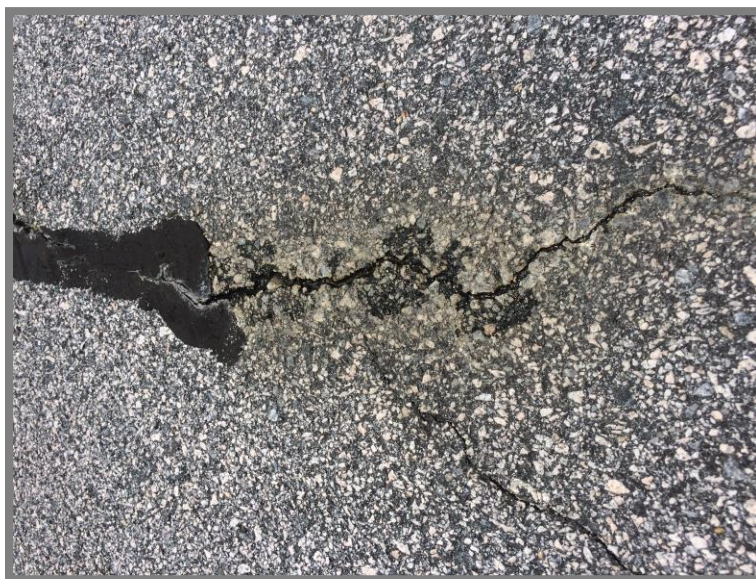
Swelling – Taxiway L and Taxiway F Intersection

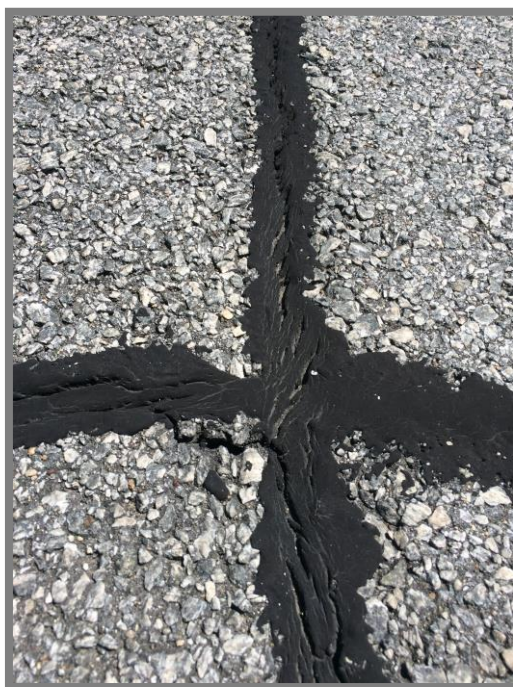
Weathering and L&T Cracking –Runway 4-22 Shoulder

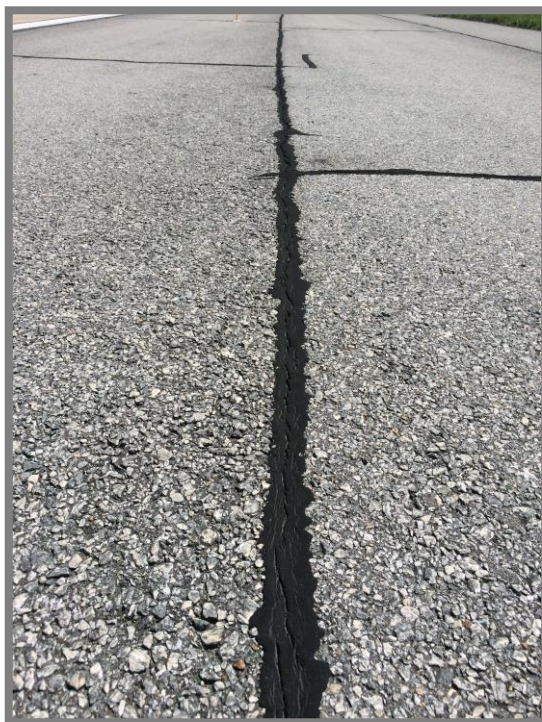
Weathering & Longitudinal Cracking – Runway 4-22

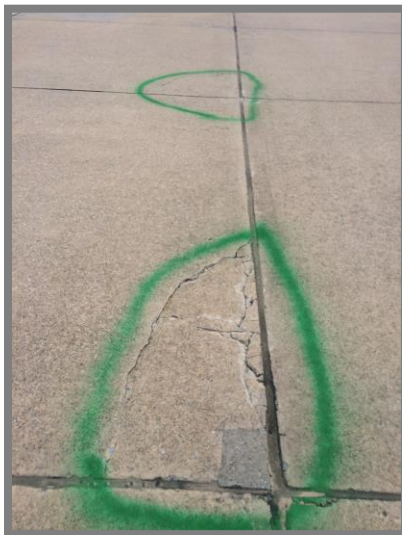
Corner Break – General Aviation Apron

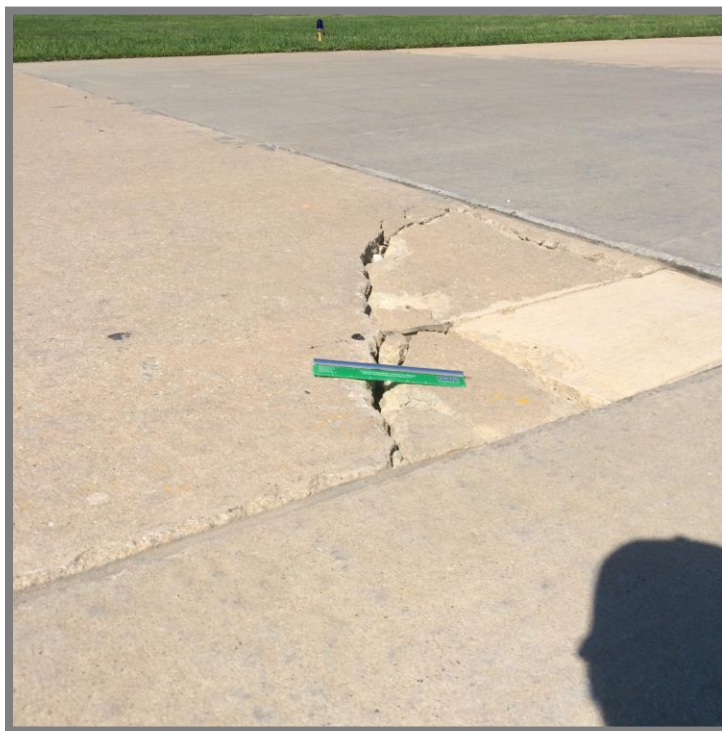
Corner Break – Fire Station Apron

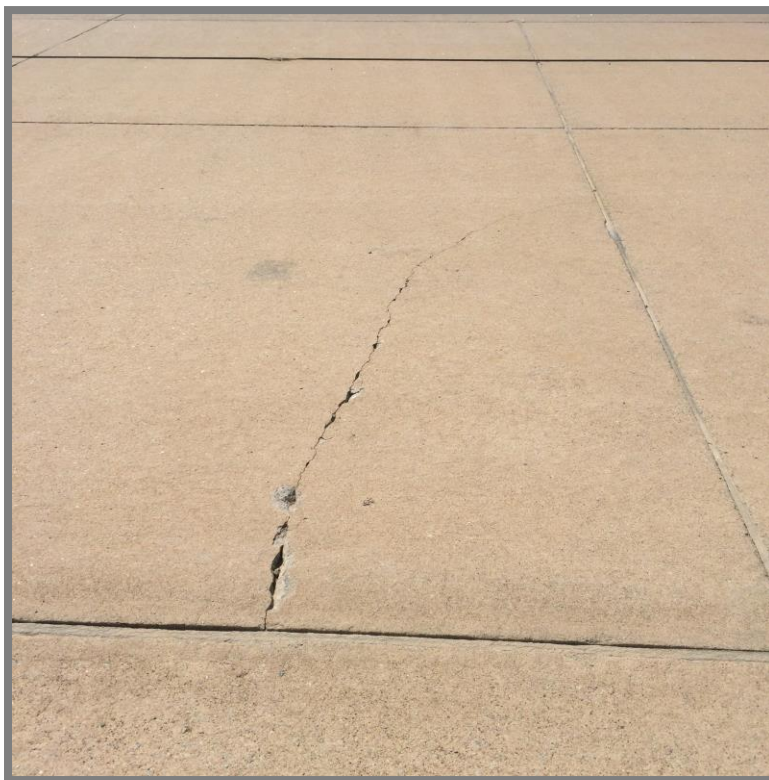
Longitudinal/Transverse/Diagonal Crack – Fire Station Apron

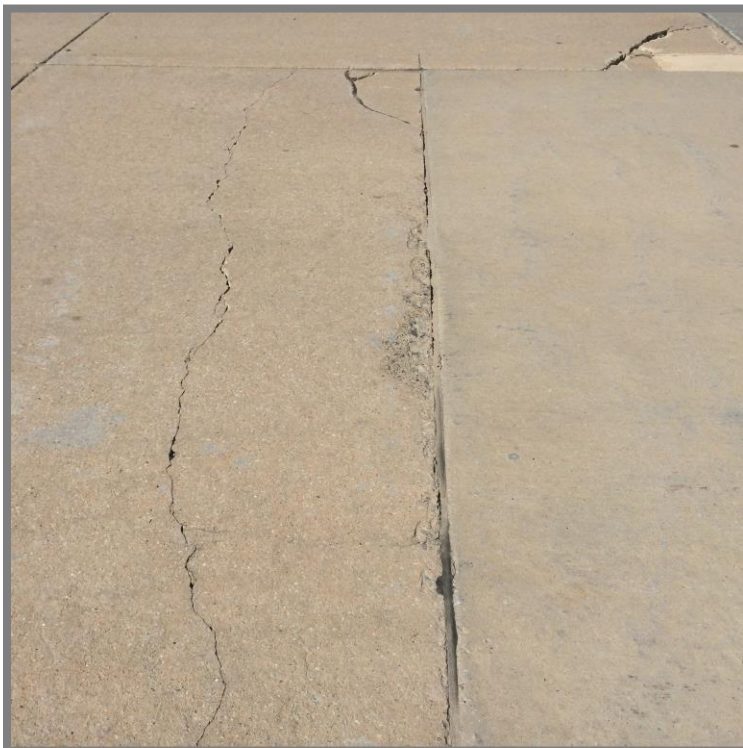
Longitudinal/Transverse/Diagonal Crack – Fire Station Apron

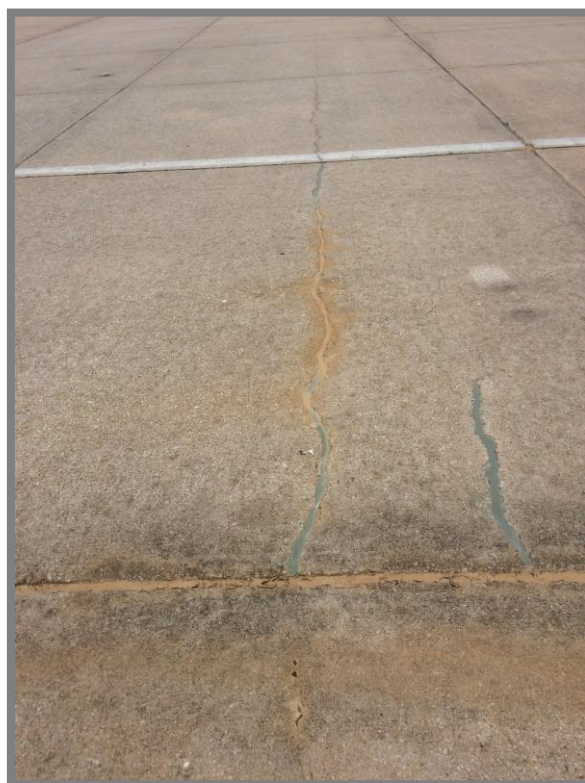
Longitudinal/Transverse/Diagonal Crack – Hangar 1

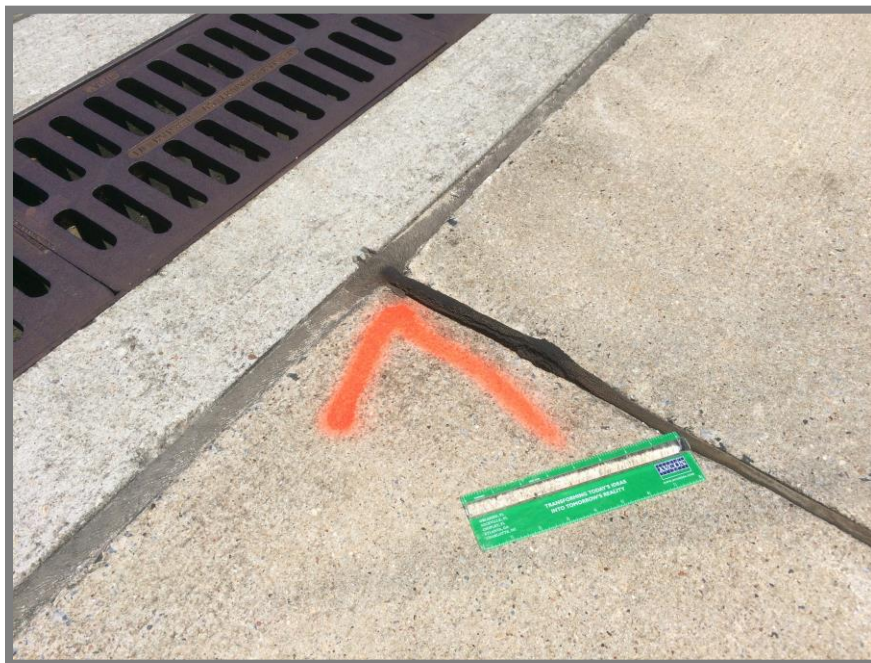
Joint Seal Damage – North Cargo Area

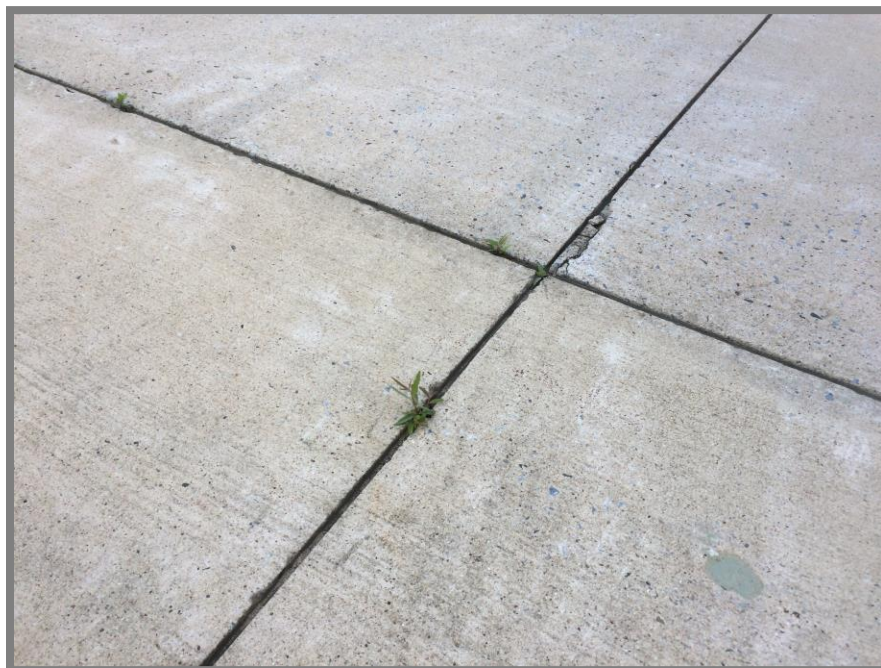
Joint Seal Damage – North Cargo Area

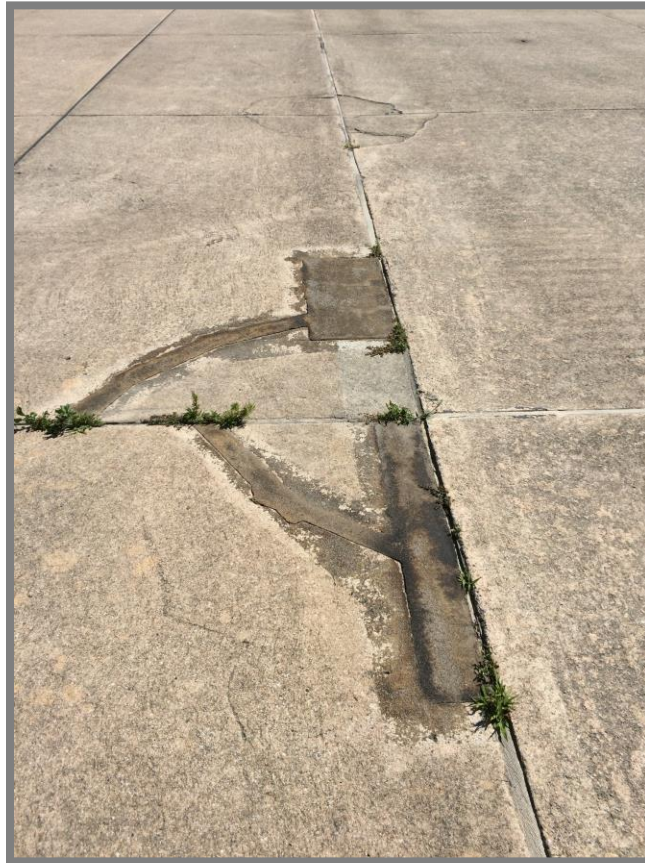
Joint Seal Damage & Patching – Fire Station Apron

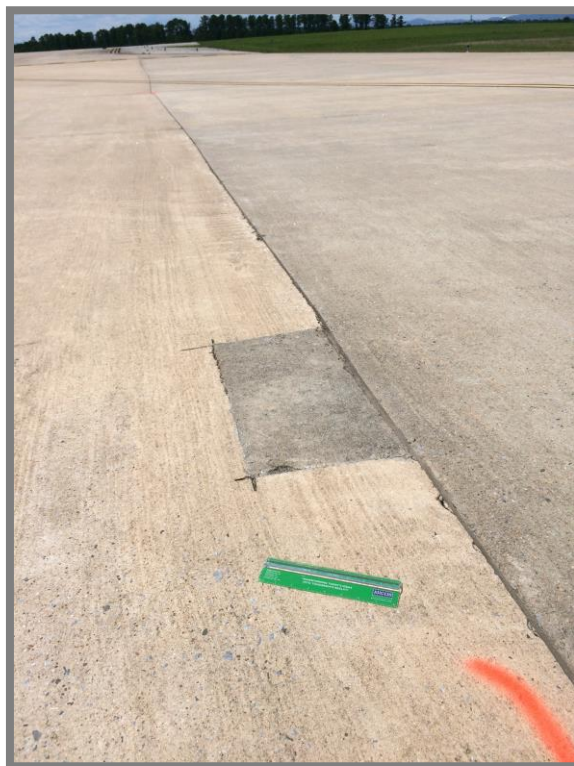
Patching – Taxiway L9

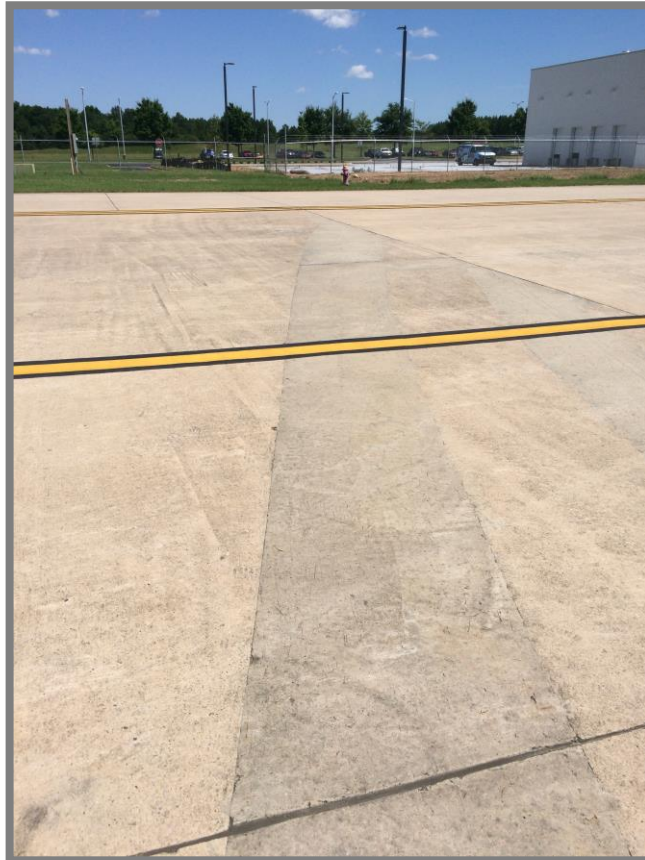
Utility Patching – North Cargo Area

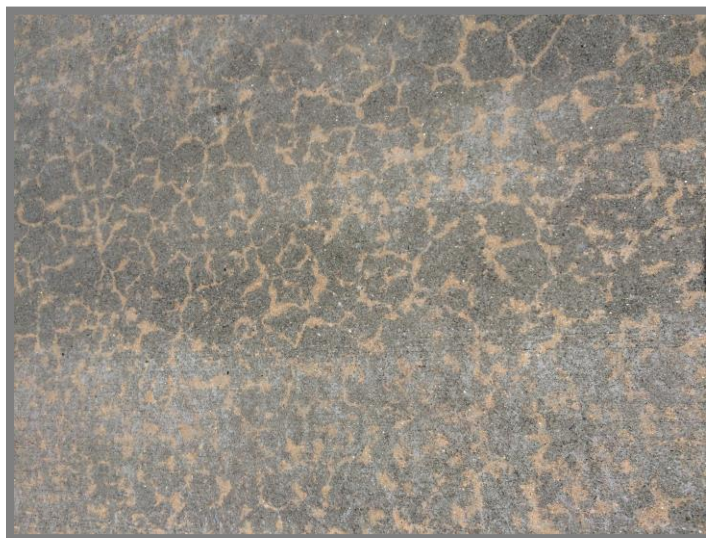
Scaling – Hangar 2

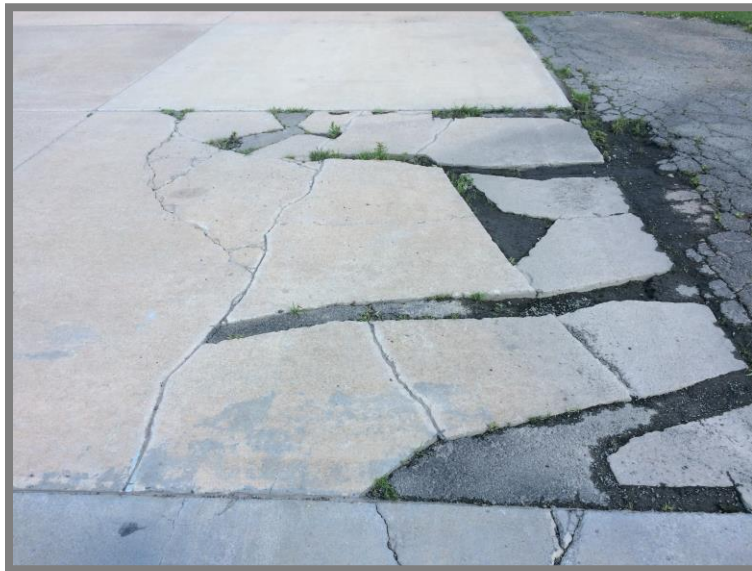
Shattered Slab – Fire Station Apron

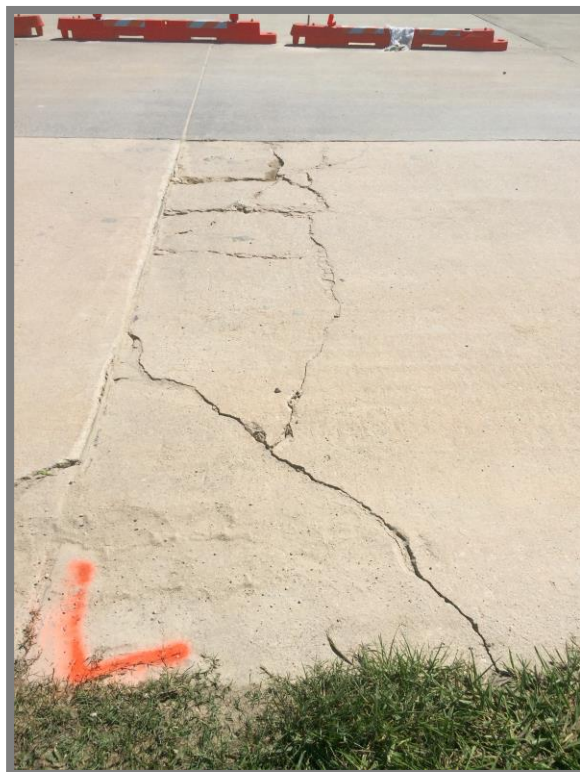
Shattered Slab – Fire Station Apron

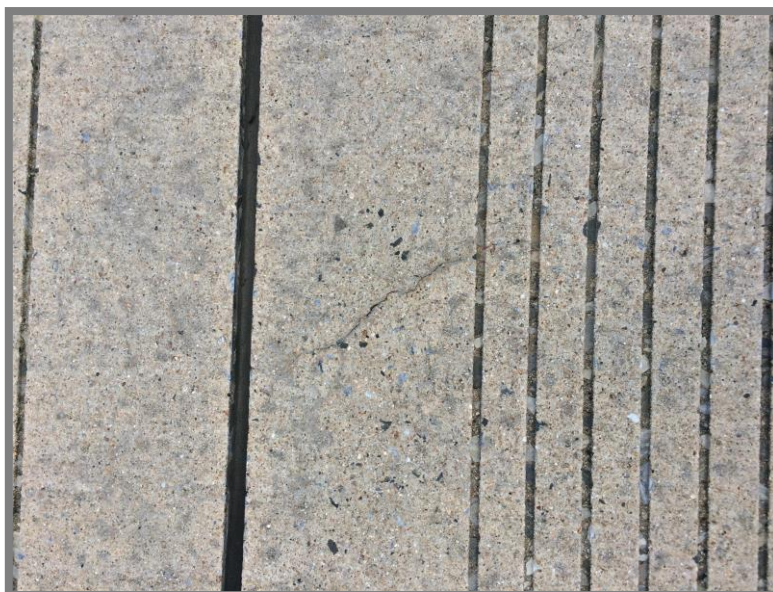
Shrinkage Cracking – Runway 4-22

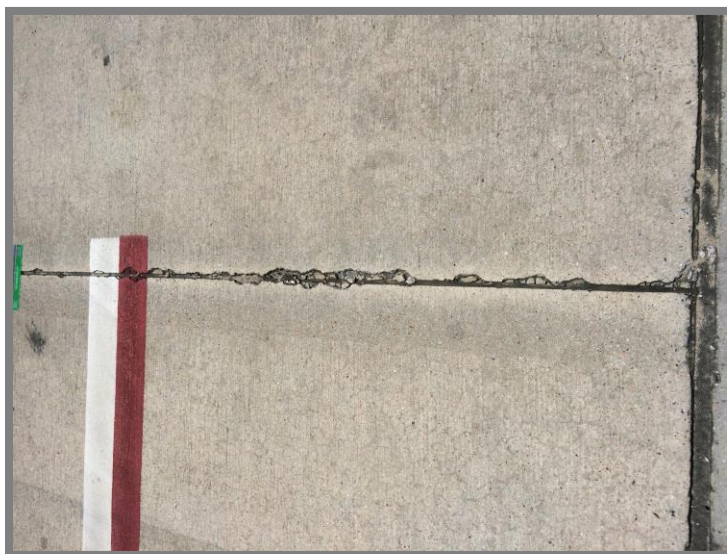
Joint Spalling – North Cargo Area

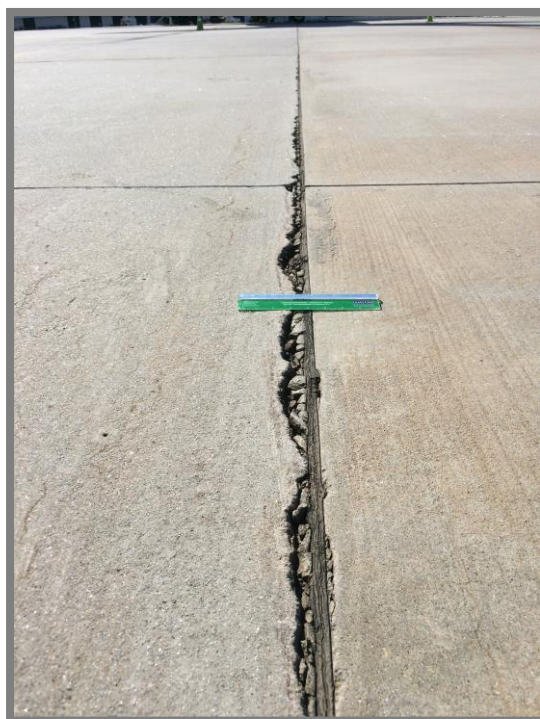
Joint Spalling – South Cargo Area

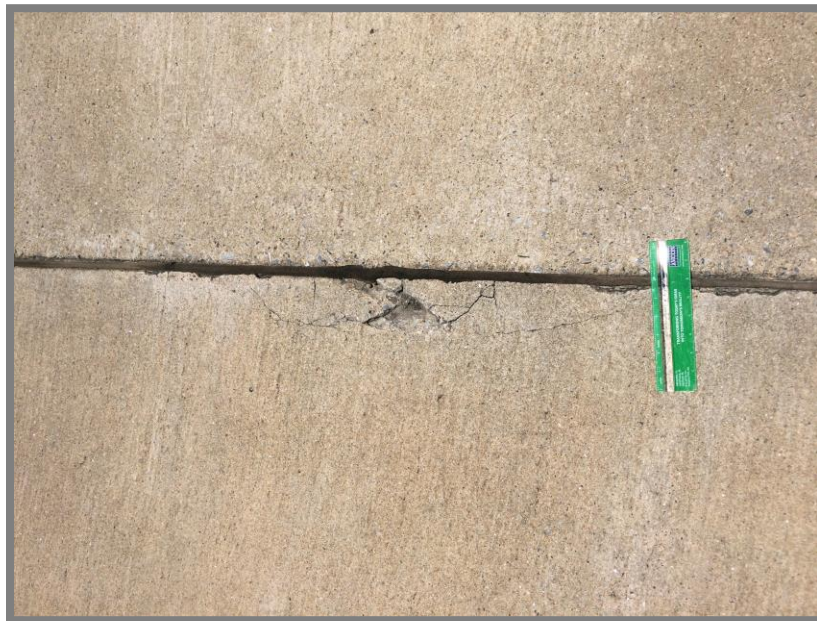
Joint Spalling – North Cargo Area

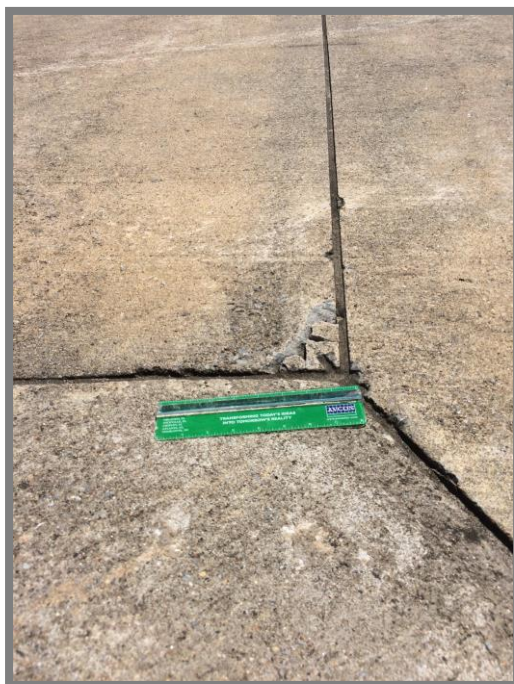
Corner Spalling – Taxiway L9

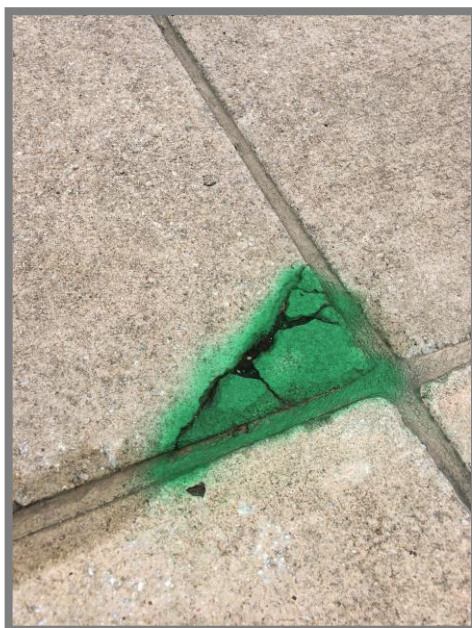
Corner Spalling – Hangar 1
