GREENVILLE-SPARTANBURG INTERNATIONAL AIRPORT

DECEMBER 2019
AIRPORT MASTER PLAN UPDATE
APPENDIX A: PAVEMENT MANAGEMENT PLAN

AIRPORT PAVEMENT MANAGEMENT SYSTEM UPDATE

AUGUST 2018

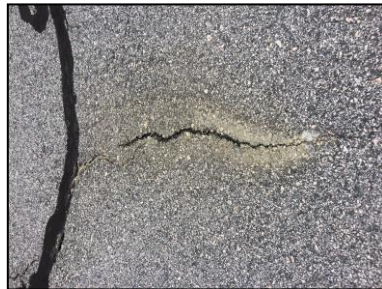
For this update, Section 70, 80 and 90 were duplicated using the data from 2016 report due to limited access to the runway during the inspection period. The AC pavements experienced more distresses than the PCC pavement portions. Sections 70, 80 and 90 consist of an 84, 75, and 81 PCI, respectively. Throughout the runway, the following distresses were observed: weathering, swelling, linear cracks and patching, all of which were low-severity for the AC pavement portions.

Swelling

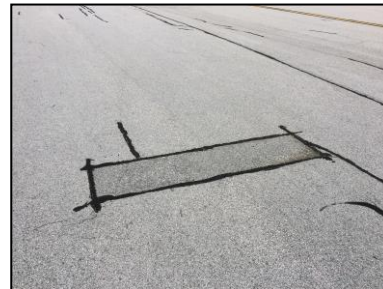
Small Patch

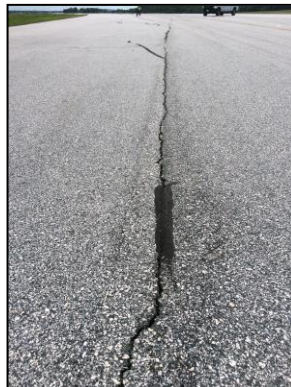
L&T Crack, Weathering,
Swelling and Rutting

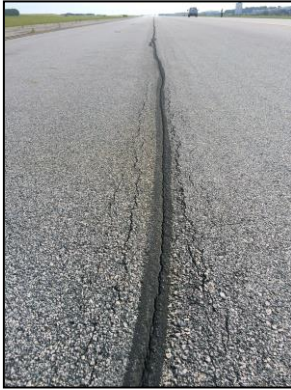
L&T Crack

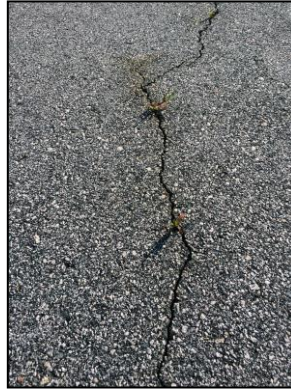
L&T Crack and Swelling

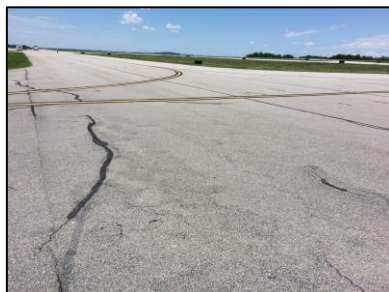
L&T Crack and Swelling

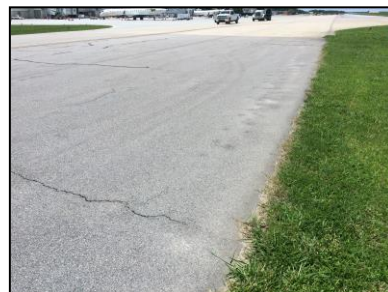
L&T Crack and Swelling

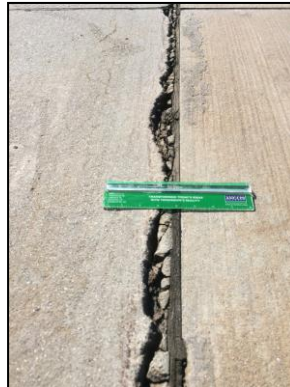
Joint Spall

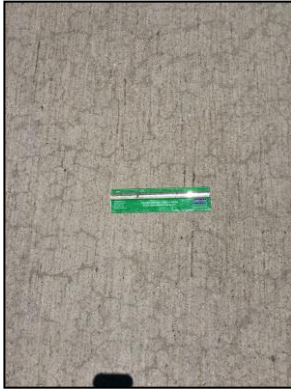
Shrinkage Crack

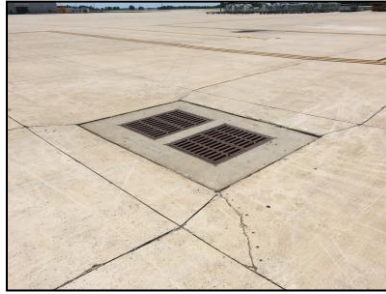
Corner Break

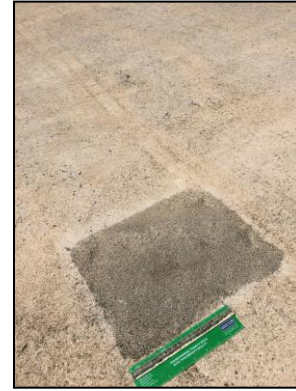
Small Patch

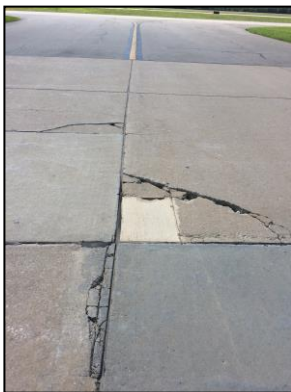
Corner Break
and Small Patch

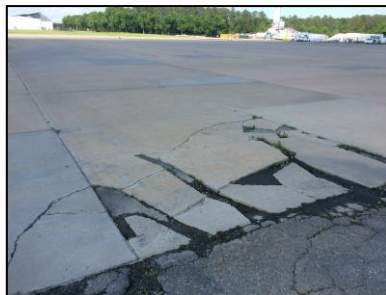
Shattered Slab

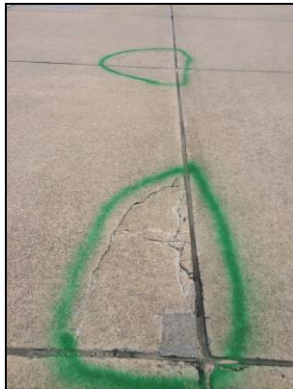
Corner Break

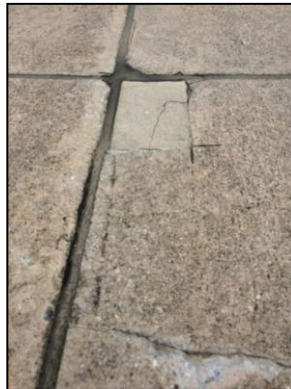
Small Patch

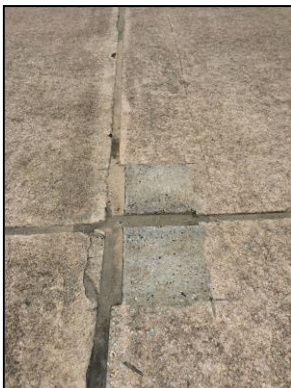
Small Patch

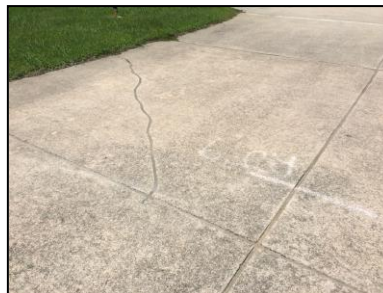
Corner Break

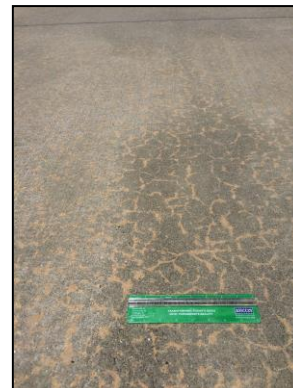
Shrinkage Crack

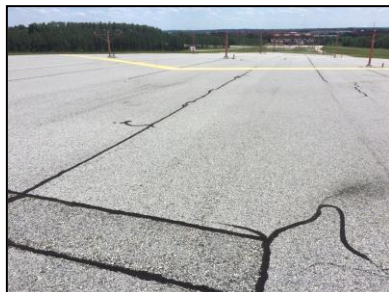
Two blast pad pavement sections are defined on the airfield. AC Section BP-04 shows an extensive amount of distress such as low and medium severity L&T cracks, swelling, and medium severity weathering. AC Section BP-22 experienced more deterioration than Section BP-04; the distresses experienced in this section are bleeding, low, medium, and high severity L&T cracks, oil spills, swelling and weathering. A summary of the section condition is represented in **Table 3.17**.

L&T Crack

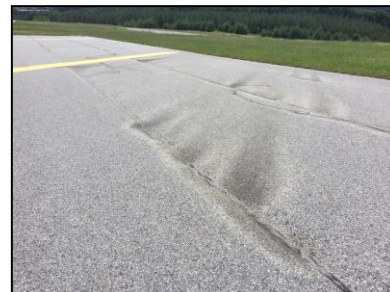
L&T Crack and Swelling

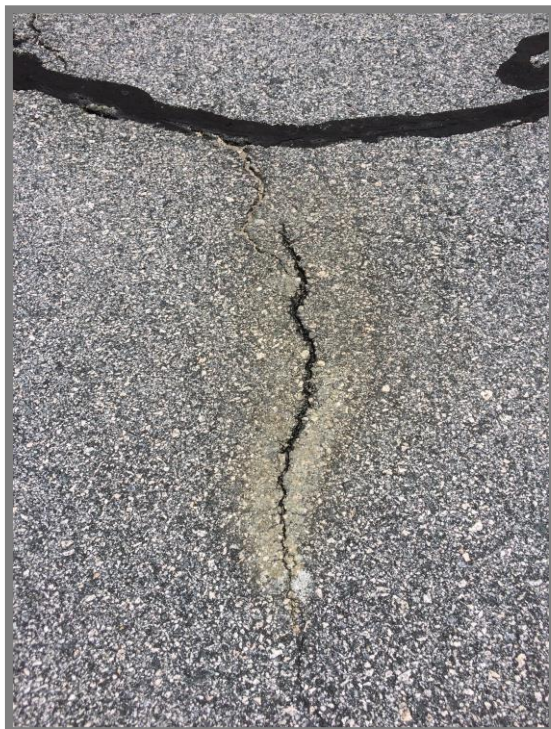
Swelling is characterized by an upward bulge in the pavement's surface. A swell may occur sharply over a small area or as a longer, gradual wave. Either type of swell can be accompanied by surface cracking.

Swelling – Taxiway L and Taxiway F Intersection

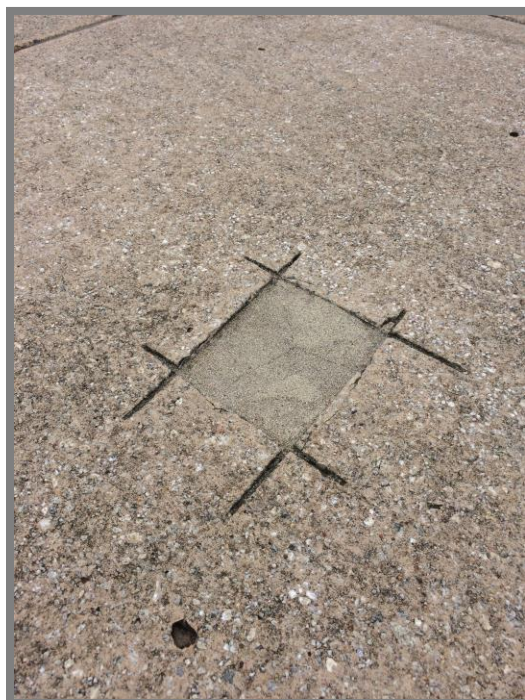
Patching is identified as a distress because it is not an original design feature of the pavement structure. This distress type includes all partial-depth and full-depth patches, as well as utility cuts. Low-severity patches are in good condition, medium-severity patches have some deterioration and/or have a minor effect on ride quality, and high-severity patches are badly deteriorated and producing FOD or have a significant effect on ride quality.

Patching – Air Carrier Terminal Apron

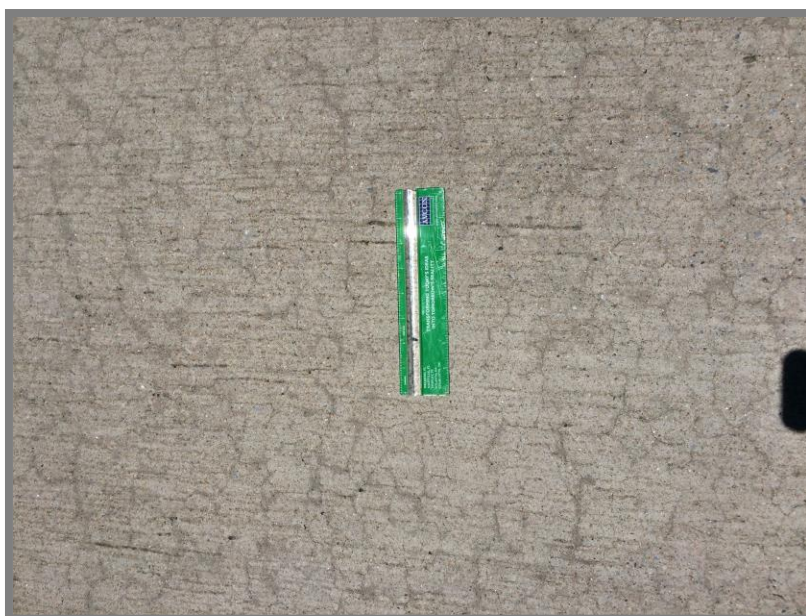
Scaling – North Cargo Area
